Customer:
Objective: Minimize Impact of the Aging Plant
Initiative: Complete Unit 2 Circ Water Line Repairs.

INTRODUCTION

On April 10, 2008 Intermountain Power contracted with KTA-Tator, Inc. (KTA) to determine the cause of delaminations and blistering that was occurring on a carbon fiber reinforced lining that had been installed on large diameter cooling piping in Unit 2 at the Delta, UT power plant. The KPFF lining had been applied to numerous areas within the piping system over the last three years. During the 2008 spring Unit 2 outage large areas of the coating were found to be blistered and delaminated. Mr. Ray Tombaugh, Senior Consultant, was responsible for performing the investigation and preparing this report.

SUMMARY

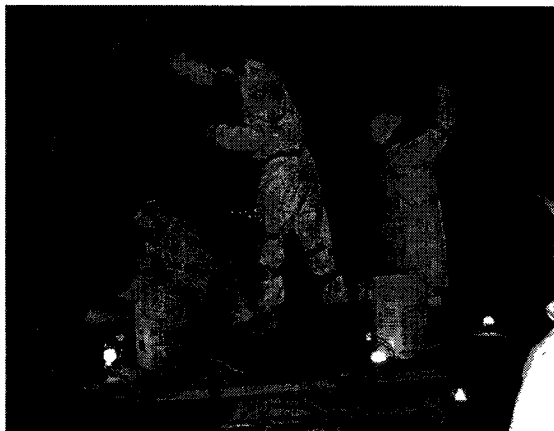
Gateway Installing Carbon Fiber
